Test report

Report Number: MU240726009C-01

Sample Name: Copper-Aluminum Alloy Composite Busbar Parts

Testing item: Low-temperature electrical test

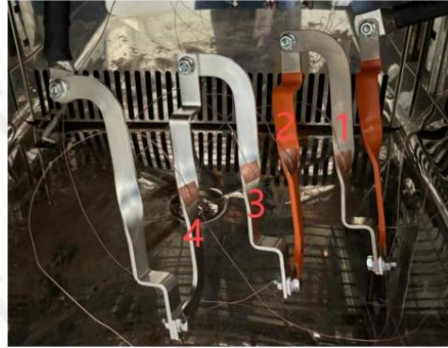
1. Low temperature: -40 \bar{y} , time: 168 hours;
2. Measure the temperature rise of the sample before and after the test. During the test, the power supply is 190A DC, and the temperature rise is monitored every 1 minute.
3. Tin-plated 5 pieces, nickel-plated 5 pieces, totaling 10 pieces (3 pieces in each group are charged, and 2 pieces are not charged);
4. After testing, observe the sample surface for any discoloration or cracks.
5. The monitoring locations are shown in the image below;

| monitoring point | Collection ($^{\circ}\text{C}$) | | | | Environment ($^{\circ}\text{C}$) | Temperature rise ($^{\circ}\text{C}$) | | | |
| | 1. Nickel | 2. Nickel | 3. Tin | 4. Tin | | 1. Nickel | 2. Nickel | 3. Tin | 4. Tin |
| 0H | 69.0 | 66.5 | 72.2 | 72.2 | 29.6 | 39.4 | 36.9 | 42.6 | 42.6 |
| 10~11H (average) -31.7 | | -32.5 | -31.1 | -31.5 | -40.5 | 8.8 | 8.0 | 9.3 | 9.0 |
| 157~158H (average) -31.7 | | -32.5 | -31.3 | -31.6 | -40.4 | 8.7 | 7.9 | 9.1 | 8.8 |
| 168H | 73.6 | 70.1 | 75.8 | 76.0 | 33.2 | 40.4 | 36.9 | 42.6 | 42.8 |

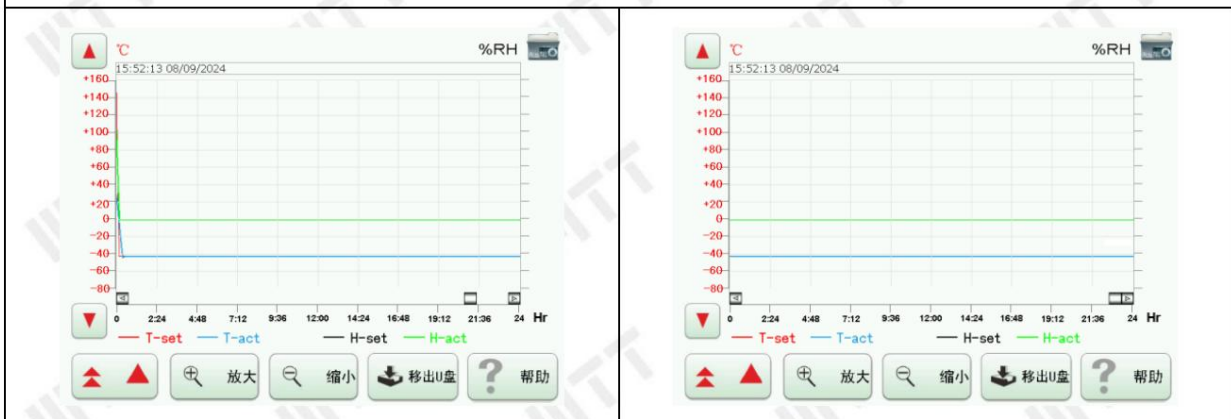
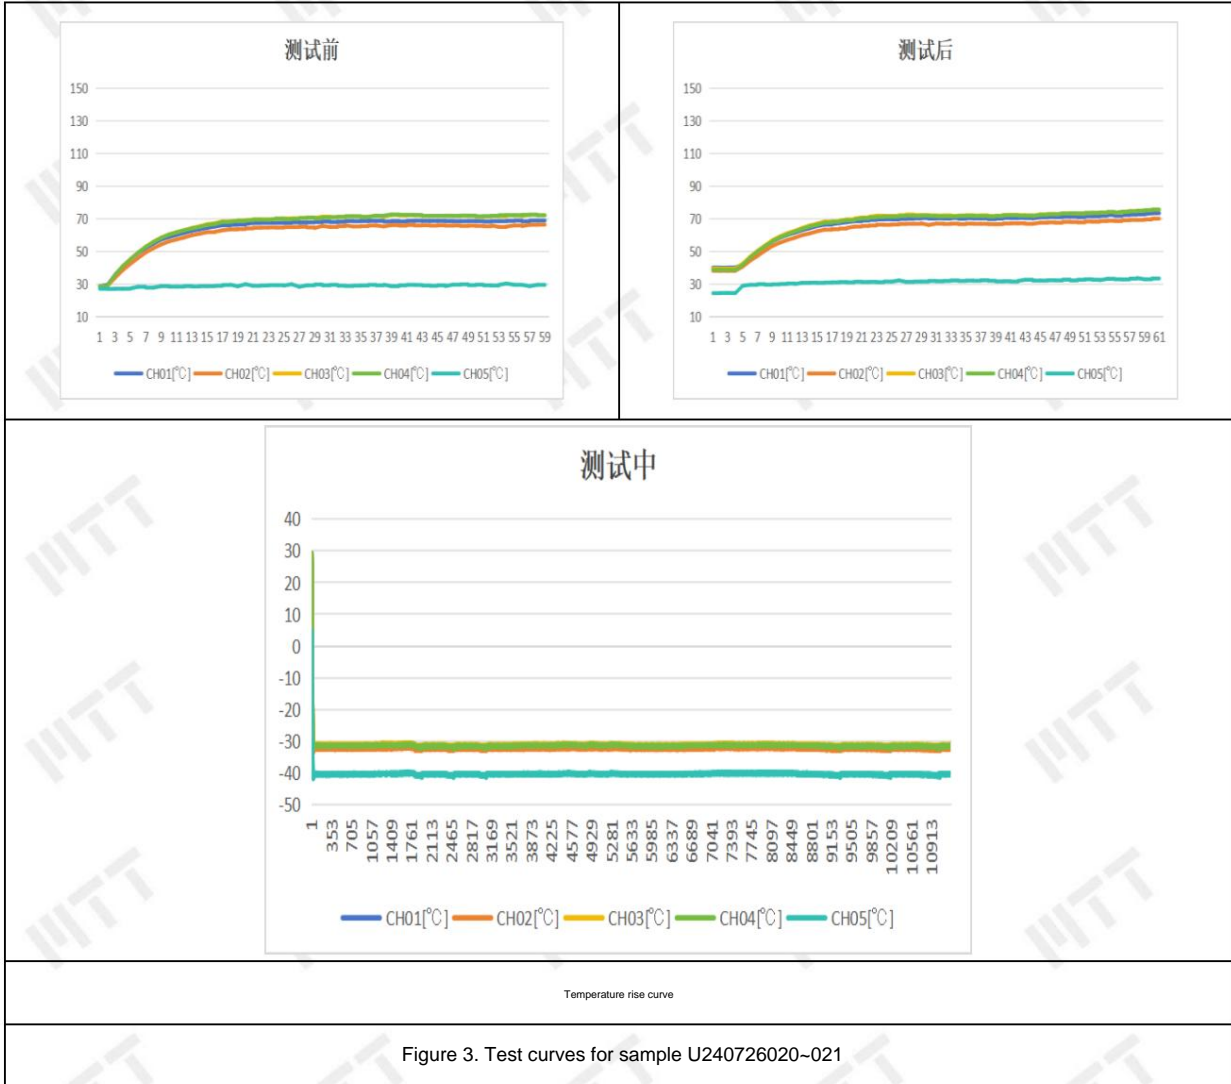
Temperature curve

| Sample number | Test results |
|---|---|
| U240726020~021 | After testing, a visual inspection of the sample surface revealed no discoloration or cracks. Temperature rise data are shown in the table below. |

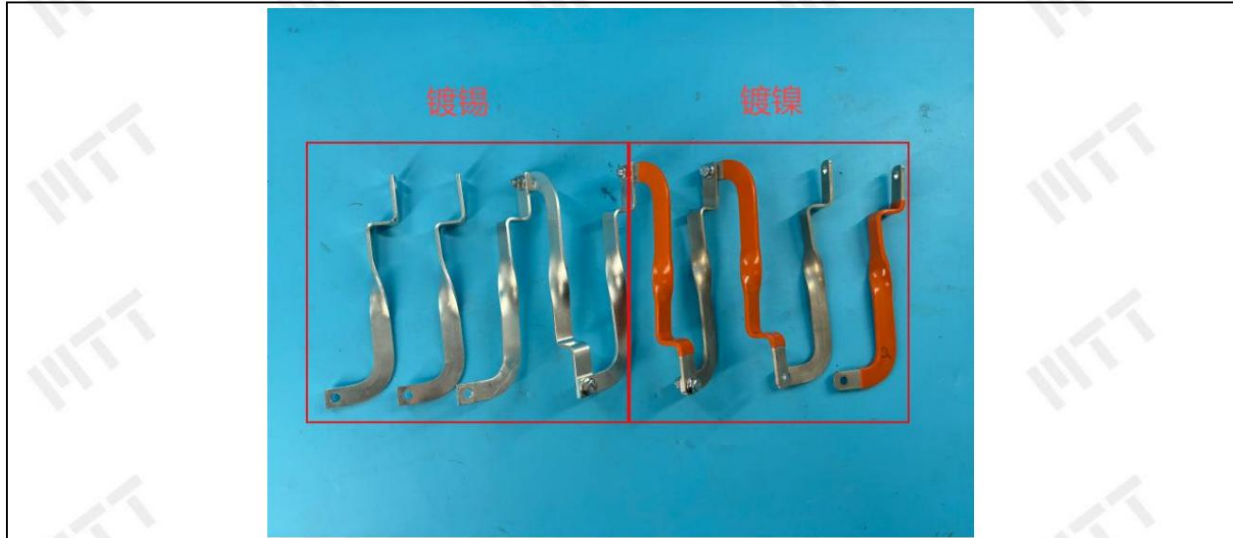
Figure 4. Images of sample U240726020-021 after testing
