Copper-aluminum alloy composite flat wire live salt spray test report

Number: 20240926-1

Sample Name	Copper-aluminum alloy composite flat wire	
Product Specifications	16mmX3mm	(Width x Thickness)
Material grade	T2/8030	
Test start time:	2024-07-27	
Test end time:	2024-09-24	
Test Results	Please see the next page (unless otherwise specified, this report is only responsible for the results of copper-aluminum composite flat wire).

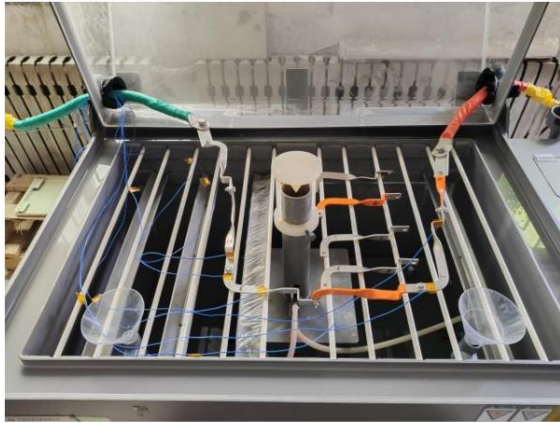
Photos before the experiment

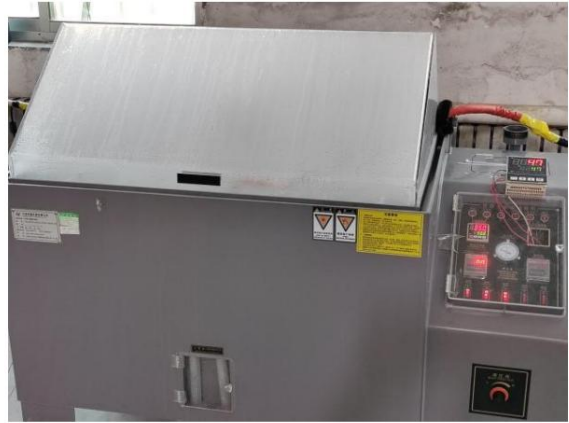
Photos of the experiment process

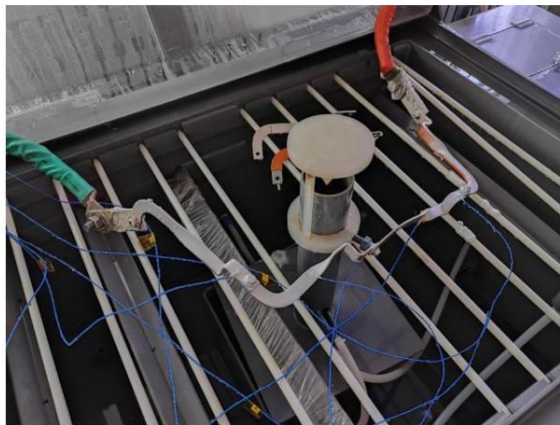
Photos after 500 hours of salt spray

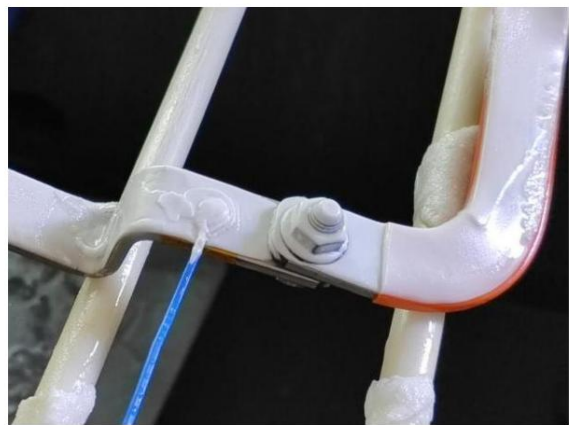
A partial photograph taken after 500 hours of salt spray (1 mm of salt deposited on the upper surface).

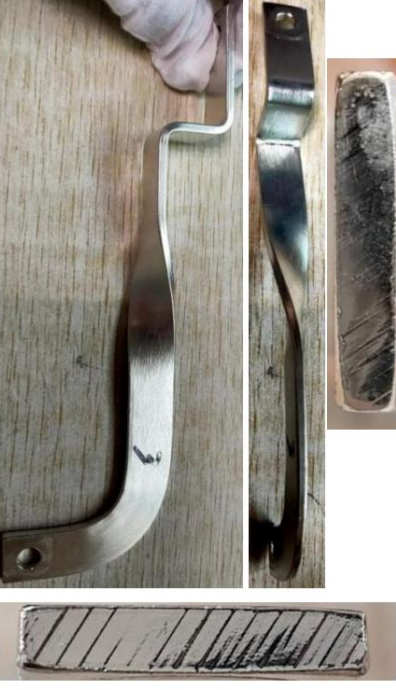
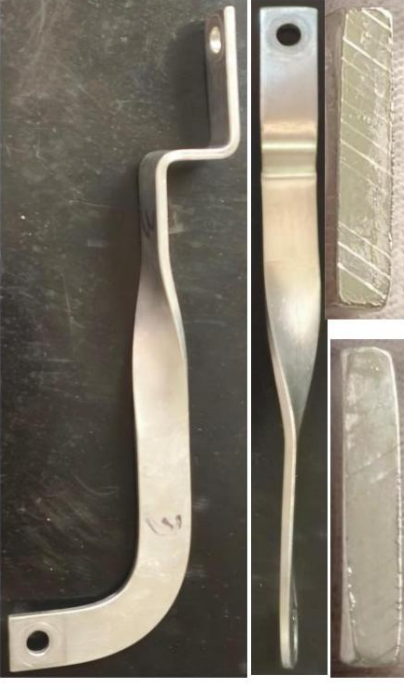
3

sample	Salt spray	96 hours after salt spray	240h salt spray
Serial Number

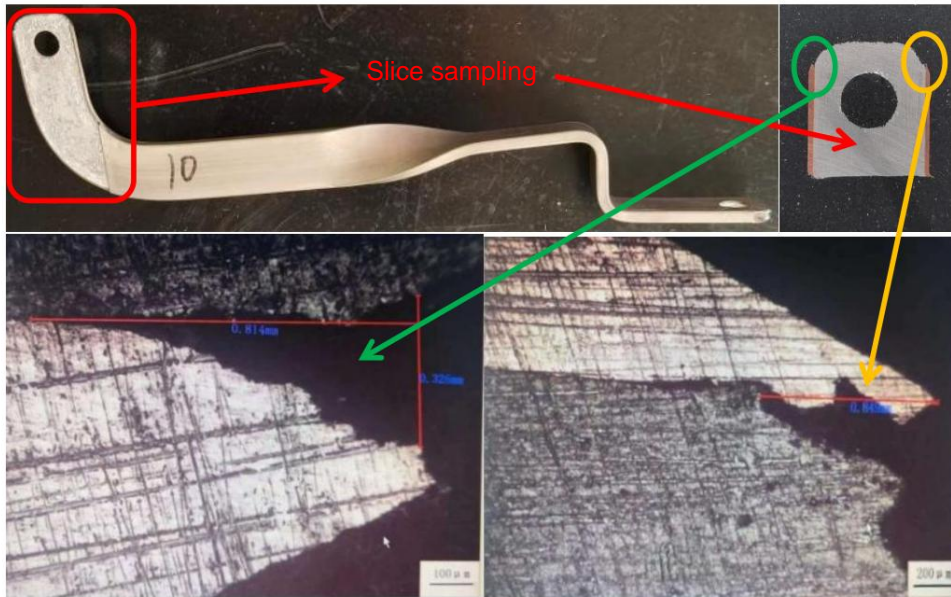
1. Metallographic analysis after 220h salt spray test. Sample No. 10 is a cut sample with a nickel-plated end. After 96h + 124h = 220h, the mating end...

A stamping delamination test was conducted, and metallographic analysis was performed on a section at one end. The porosity depth between the copper and aluminum at the end was 0.814 mm to 0.849 mm, and the maximum porosity was...

0.326mm, details are as follows:

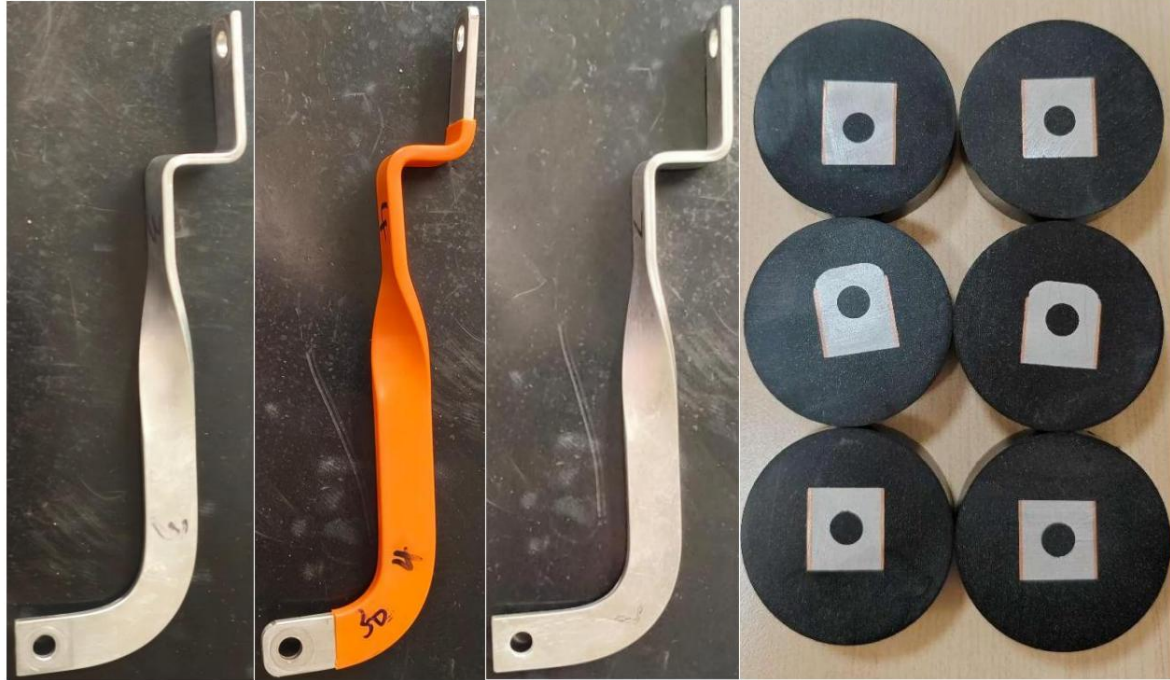
3. Metallographic examination after 336 hours of salt spray testing. Samples No. 3, 4, and 8 were then subjected to a salt spray test for 96 hours + 240 hours = 336 hours.

Metallographic analysis was performed on sections from both ends.

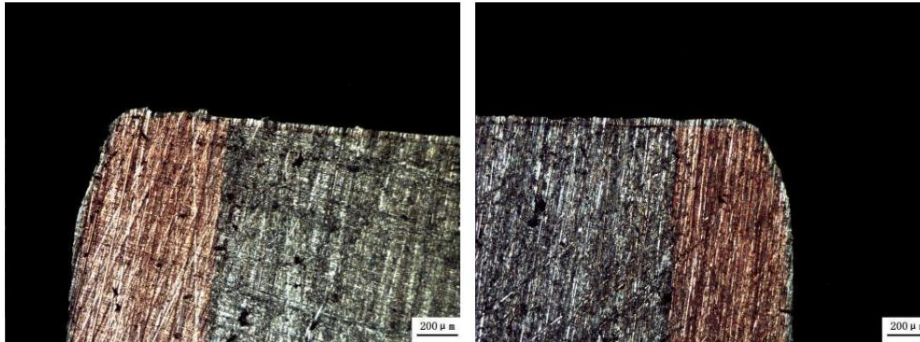
Sample No. 3

3.1 Among them, No. 3 and No. 8 are tin-plated products with full coating. The surface coating is visible and not corroded, and the substrate is protected and not corroded.

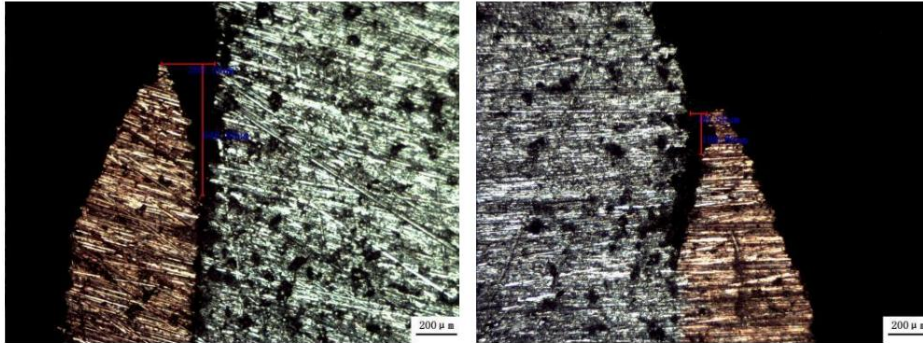
Sample No. 4-1

Sample No. 4 is a cut sample from a nickel-plated end. Corrosion occurs along the copper-aluminum interface, forming pores. Pore depth...

0.199-0.965mm, pore width 0.081-0.315mm.

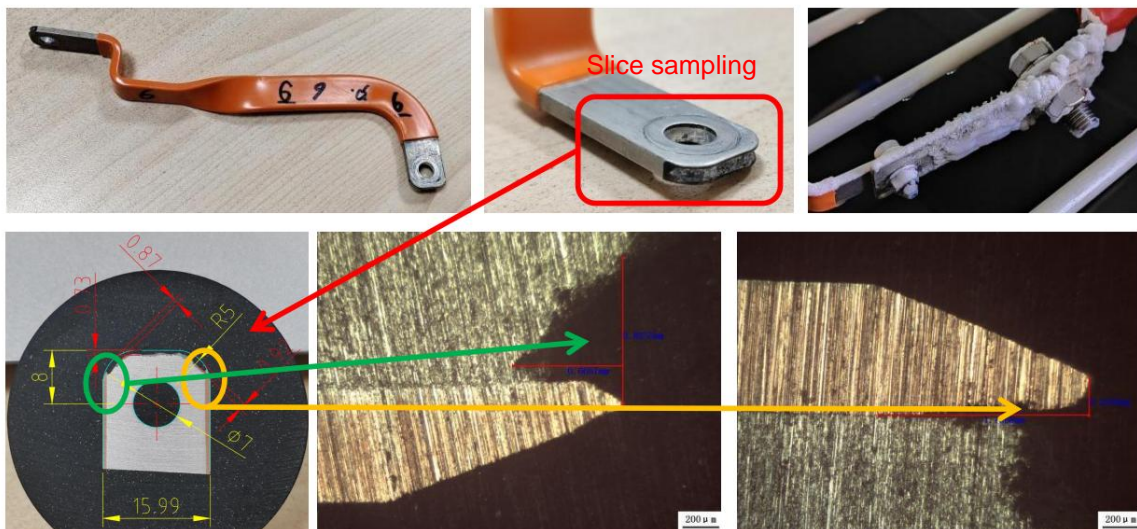
4.1 Sample No. 6 is a cut sample with an electroplated nickel end. One end overlaps with sample No. 5, and the end face is not corroded; the other end connects to the connector.

Overlapping, aluminum corrosion at the end face. The maximum corrosion depth of the end pores is within the aluminum core near the bonding layer, with pore depths ranging from 0.61mm to 1.16mm.

The pore width is 0.81 mm; the corrosion depth of the aluminum core at the end is 0.73 mm to 0.92 mm.

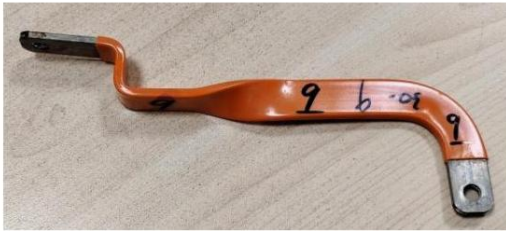
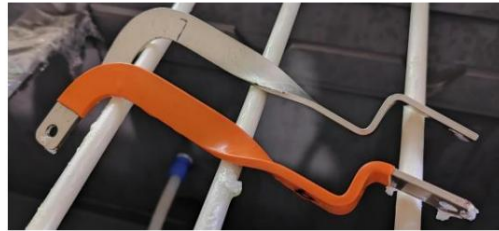
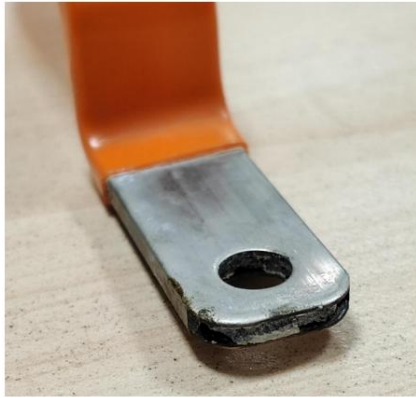
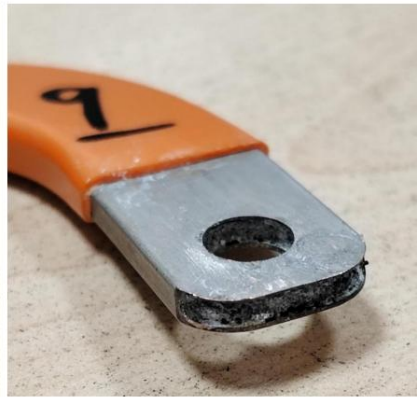
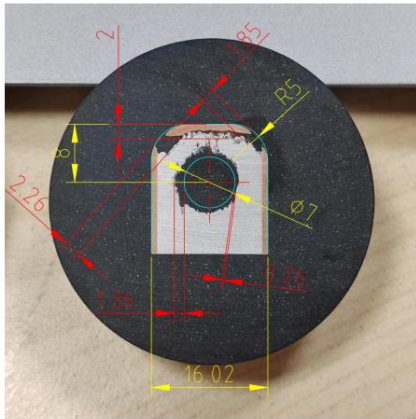
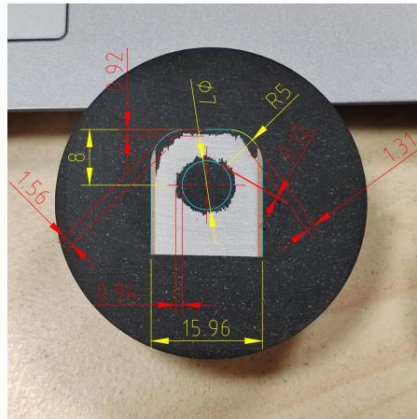
No. 9 is a cut sample without electroplated nickel ends. Both ends show aluminum corrosion, with a corrosion depth of 1.85mm at both aluminum cores.

The depths of corrosion on the aluminum core inside the hole are 2.26mm and 0.92mm-1.56mm. The corrosion depths are 0.26mm-2.26mm and 0.12-0.94mm respectively. In actual working conditions, the corrosion inside the hole is...

When sealed, no corrosion will occur.
