TEST REPORT

Report No: 2015040K2286X
Product: copper clad aluminum busbar
Type: 80*10/50*5
Applicant: YanTai Fisend Bimetal Co.,Ltd

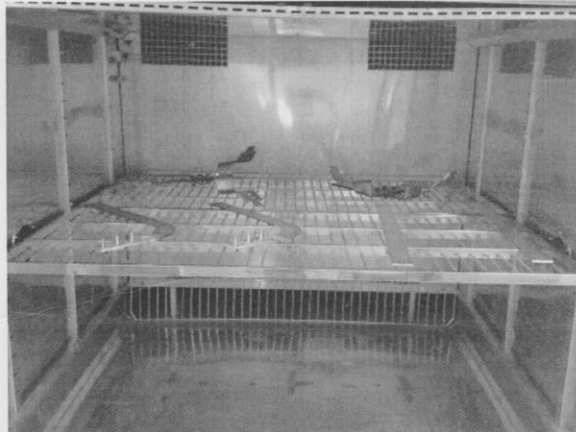
testing

Low temperature: -40°C
High temperature: 140°C
Rate : 6°C/min
Number of cycle 1000
